Flood Control Project Maintenance**2011 Structure Summary Report****Overall Unit and Item Ratings****Reclamation District No. 2096 Wetherbee Lake****Wetherbee Lake Pumping Plant & Navigation Gate**

Flood Control Project Maintenance**Unit Cover Sheet****2011 Pumping Plant Inspection Results****Reclamation District No. 2096 Wetherbee Lake**

Pumping Plant
Wetherbee Lake Pumping Plant & Navigation Gate

Pumping Plant Rating	A
Date of Inspection	8/3/2011
DWR Inspector	Jim Eto
Accompanied By	Paul Casillas DWR Sutter Yard

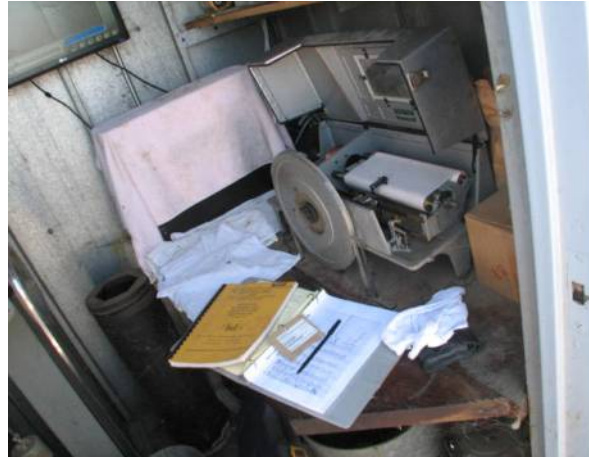
Levee Mile Report Line	1
Start Levee Mile	0.00
End Levee Mile	0.00
Location	
Category	Pump Stations
Item	Operating Log
08/03/2011 Operations Log	
jeto_t_20110808_001.jpg

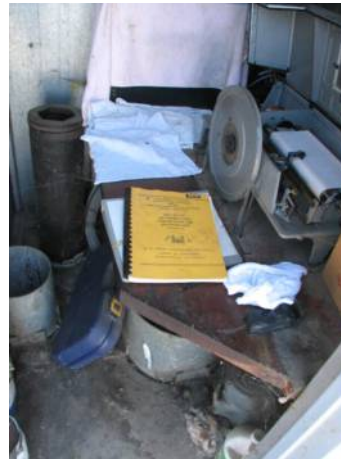
Levee Mile Report Line	2
Start Levee Mile	0.00
End Levee Mile	0.00
Location	
Category	Pump Stations
Item	Operation & Maintenance Manual
08/03/2011 Operations and Maintenance Manual	
jeto_t_20110808_002.jpg

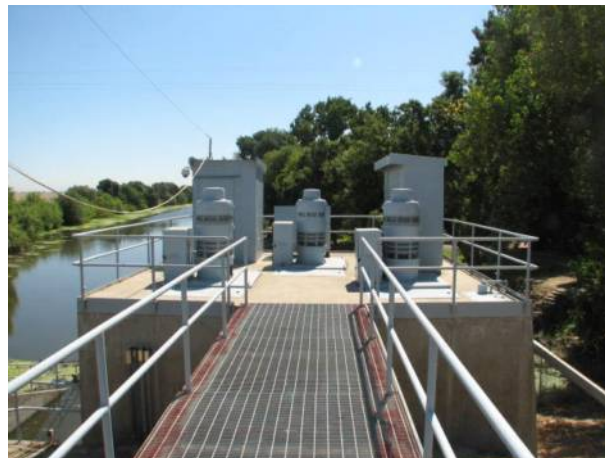
Levee Mile Report Line	3
Start Levee Mile	0.00
End Levee Mile	0.00
Location	
Category	Pump Stations
Item	Plant Building
08/03/2011 "Building" shown in background on left, structure houses the pump controls.	
jeto_t_20110808_003.jpg

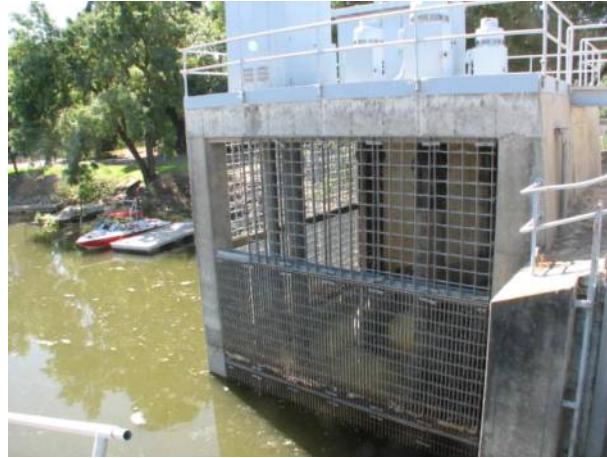
11	0.00	0.00	Pump Stations	Sumps/Wet Well		A	Inspector Comments: Sump is clear of debris.	37.773593 ° -121.298442 °	37.773593 ° -121.298442 °	12
12	0.00	0.00	Pump Stations	Trash Racks		M	Inspector Comments: Trash rack is present, however one panel is missing from rack.	37.773593 ° -121.298442 °	37.773593 ° -121.298442 °	13 Y
13	0.00	0.00	Pump Stations	Trash Rakes		N	Inspector Comments: No trash rake present.	37.773593 ° -121.298442 °	37.773593 ° -121.298442 °	14
14	0.00	0.00	Pump Stations	Sluice / Slide Gates		N	Inspector Comments: No slide gates present	37.773593 ° -121.298442 °	37.773593 ° -121.298442 °	15

Levee Mile Report Line	12
Start Levee Mile	0.00
End Levee Mile	0.00
Location	
Category	Pump Stations
Item	Trash Racks
08/03/2011 Section of trash rack is missing, missing section would be in upper left of photo.	
jeto_t_20110808_004.jpg

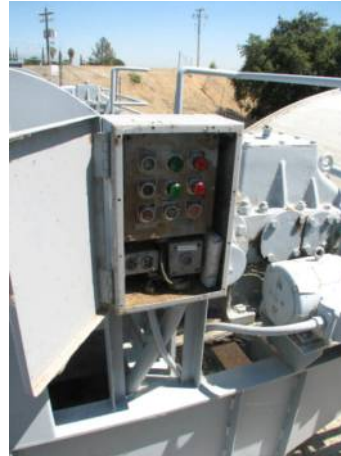
Levee Mile Report Line	15
Start Levee Mile	0.00
End Levee Mile	0.00
Location	
Category	Pump Stations
Item	Electric Gate Operators
08/03/2011 Photo shows radial arm gate controls.	
jeto_t_20110810_028.jpg

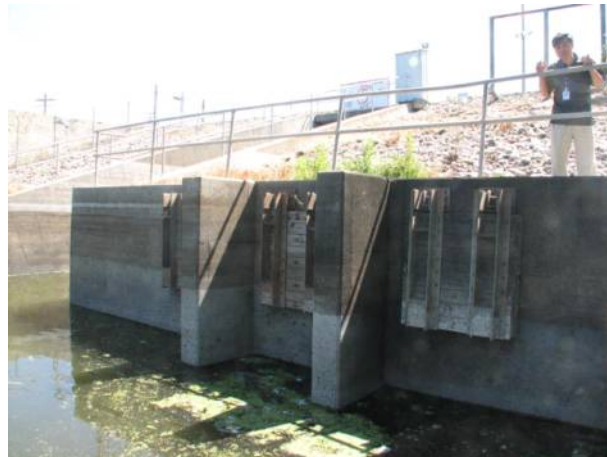
Levee Mile Report Line	18
Start Levee Mile	0.00
End Levee Mile	0.00
Location	
Category	Pump Stations
Item	Flap Gates
08/03/2011 Flap gates shown.	
jeto_t_20110808_005.jpg

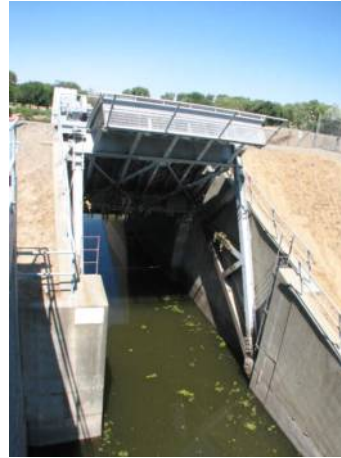
19	0.00	0.00	Pump Stations	Closure Structures		A	Inspector Comments: Radial arm gate acts as closure structure, gate was open at time of inspection.	37.773593 ° -121.298442 °	37.773593 ° -121.298442 °	20 Y
20	0.00	0.00	Pump Stations	Security Fencing		A	Inspector Comments: Security fencing is in place. CC cameras also in place.	37.773593 ° -121.298442 °	37.773593 ° -121.298442 °	21
21	0.00	0.00	Pump Stations	Intake and Discharge Pipes		A	Item inspected visually only. Item was not operated during the inspection. Inspector Comments: Pipes appear to be free of defects.	37.773593 ° -121.298442 °	37.773593 ° -121.298442 °	22
22	0.00	0.00	Pump Stations	Pressurized Pipe		A	Item inspected visually only. Item was not operated during the inspection. Inspector Comments: No evidence of erosion or leakage found.	37.773593 ° -121.298442 °	37.773593 ° -121.298442 °	23

Levee Mile Report Line	19
Start Levee Mile	0.00
End Levee Mile	0.00
Location	
Category	Pump Stations
Item	Closure Structures
08/03/2011 Radial arm gate, shown in open position.	
jeto_t_20110808_006.jpg
